# Manhole Inspection Summary

Manhole # S25CC\_032MH

**Location** Address: **1114 RIGGS AVE**

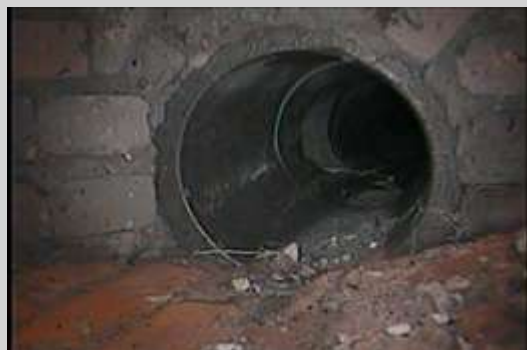
12 O'Clock Outflow

10 in. Circular Gravity Sewer  
Pipe Out @ 12 O'Clock

Pipe Height: **9.6** (in.) Rod and Bar (Angled)

Pipe Material: **Clay** ☐ Pipe Lined

Infiltration: **None** Pipe Seal Cond: **Sound**
